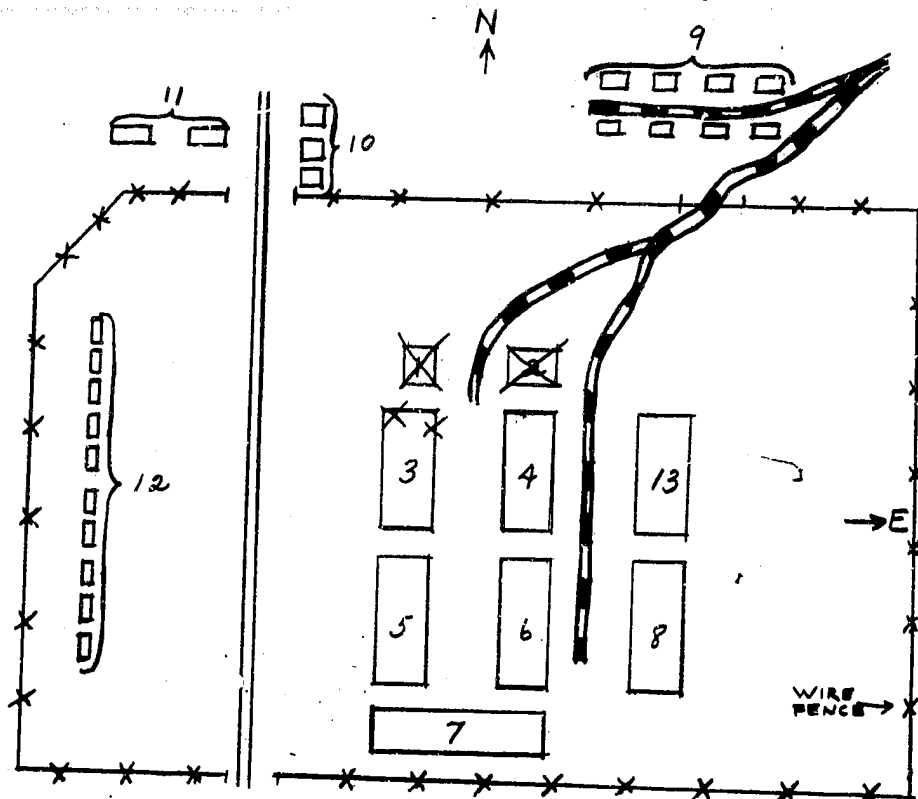
Enclosure (A): A free hand sketch, not drawn to scale, showing the location of the buildings at "Ginklu Dirbtuves Linkaiciai" (Arms Plant Linkaiciai). Numbers on the sketch are identified by the corresponding numbers listed in the descriptive legend.

The buildings at "Ginklu Dirbtuves Linkaiciai" (Arms Plant Linkaiciai)

- #1. Water supply and pumping station, completely destroyed by the Soviets on 23 Jun 41. It has been partially rebuilt by the Germans.
- #2. Electric power and natural gas installation (1400 kilowatts electric energy), completely destroyed by the Soviets on 23 Jun 41, and two-thirds rebuilt by the Germans.

- #3. Toolshop and building where 20 mm shell casings are manufactured; approximately 350' x 90'. This building was about 20% destroyed in 1941, and had not been rebuilt.

- #4. Building where rifle cartridges are manufactured; 90' x 350'.
- #5 & #6. Buildings where 105 mm artillery shells are manufactured; 100' x 380' ea.

- #7. Administrative and engineering building; approximately 6' x 200'.
- #8. Foundry - a new building - it was not completed as of 1941; approximately 100' x 380'.

- #9. Ammunition dumps (approximately 15 buildings); each 20' x 40'.
- #10. Employees' residences (three buildings).
- #11. Barracks for plant protection guards (two barracks).

- #12. Explosive departments (ten buildings).
- #13. General storage warehouse; approximately 100' x 320'.

- (a) Rifle cartridges -- 50 million per year;
 - (b) 20 mm shells -- 1 million per year;
 - (c) 105 mm shells -- 100,000 per year.
6. The water supply station [See Enclosure (A)#1] could easily be rebuilt as there were plenty of wells on the plant area. Electric power could be available from power sources in Radviliskia and Panevezys [See Enclosure (B)] if the power station [See Enclosure (A)#2] had not been fully rebuilt.

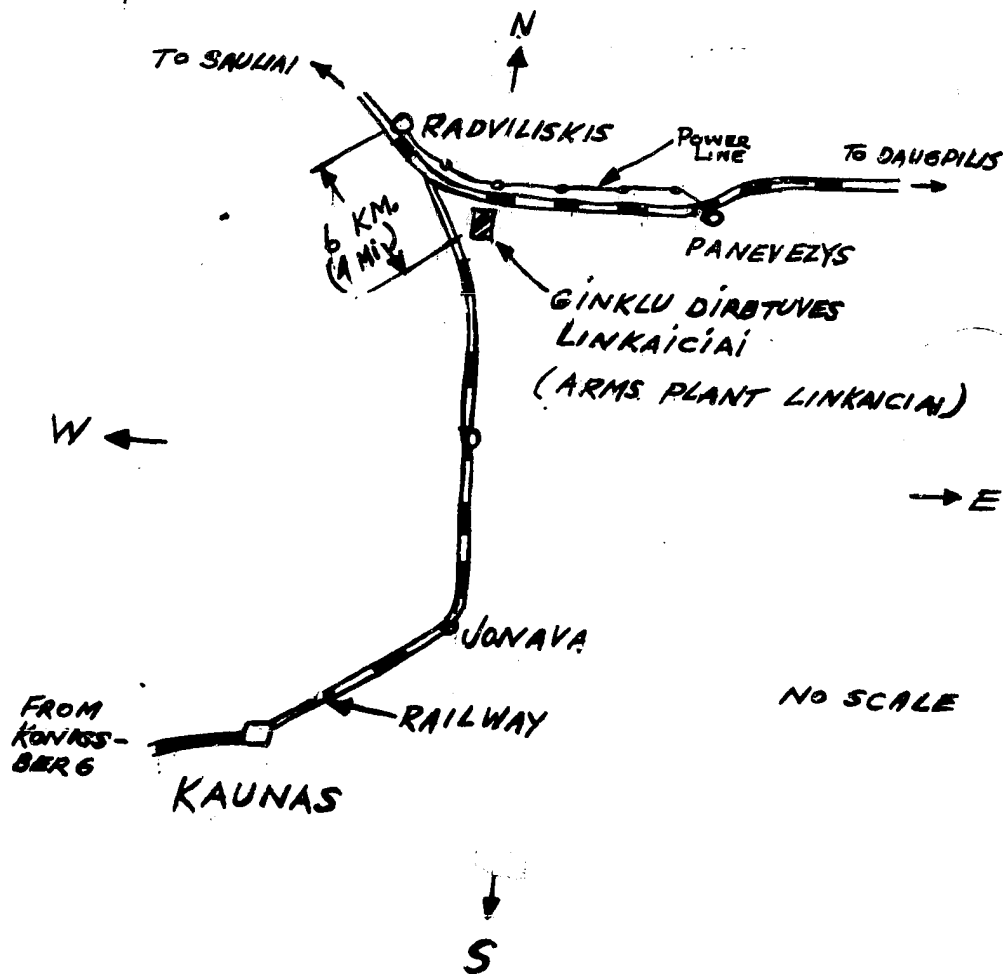
Enclosure (B): A free hand sketch, not drawn to scale, showing the location of "Ginklu Dirbtuves Linkaiciai" (Arms Plant Linkaiciai).

The location of "Ginklu Dirbtuves Linkaiciai" (Arms Plant Linkaiciai).
